Stennis Space Center (SSC) B-1 Test Facility Liquid Hydrogen Run Tank Vacuum Anomaly & Repair

Nicholas J. Nugent

April 10, 2012

Engineering & Test Directorate
NASA, Stennis Space Center

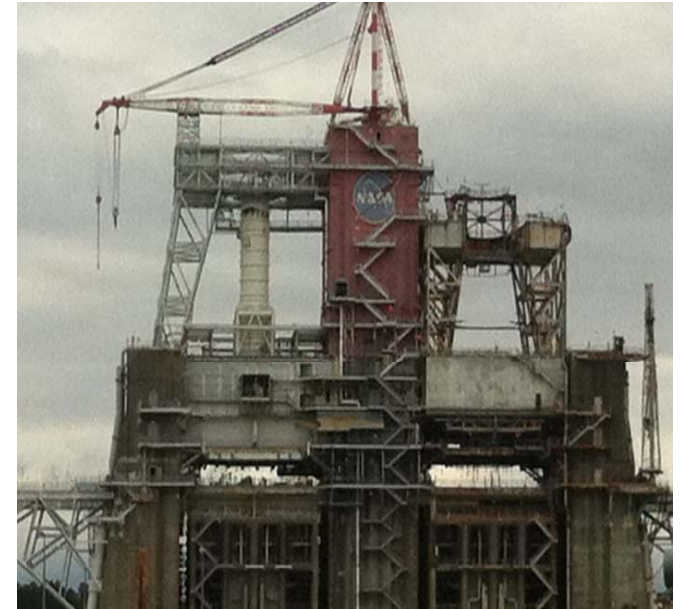
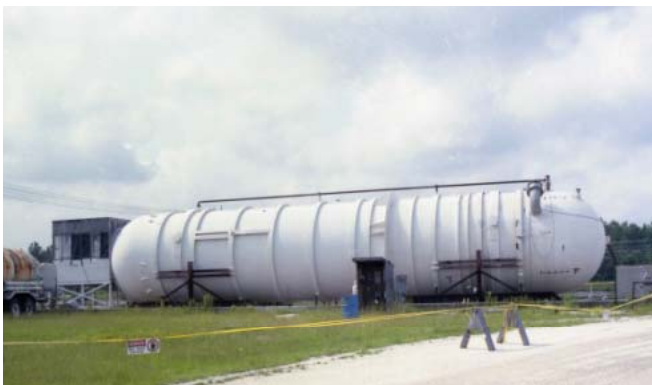
1985 Vessel on barge at SSC

- 90,000 gallon, 66 psig
- Built in 1962 by Chicago Bridge and Iron Works Company for SSFL
- Relocated from SSFL to SSC in 1984 by barge
- Inner vessel shifted in 1985 during vessel modifications and repaired before being put into service at SSC
- New 12" Run and 8" Fill and Drain Nozzles added and existing nozzles removed in 1985
- Put into service on the B-1 Test Facility in 1988 in support of SSME testing
- Last recertified in June 2004 and is due for recertification in 2014

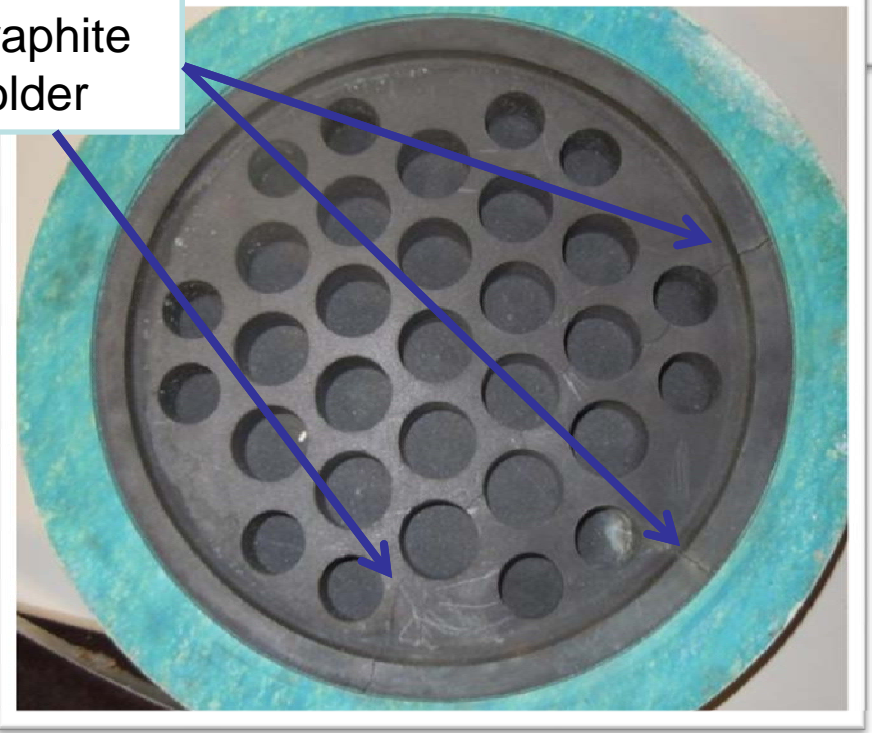
Cracks in
Graphite
Holder

- Rupture disc #1 was identified to be leaking via bagging since cracks not visible when installed
- Rupture disc was removed and found to be cracked
- Rupture disc holder was made of graphite and installed in 2003.
- Companion flange was heavily corroded
 - Wire brushing of flange was unsuccessful
 - Flange was sent to machine shop and faced for improved finishing and sealing
- Companion flange and new rupture disc installed
- 2nd rupture disc also leaking but could not be removed due to leaking isolation valve. Utilized Kenny Seal to stop leak.
- No leakage detected via bagging method

- Rupture disc replaced by lift plates
- Preventative maintenance on lift plates
- Weld or install weld caps on mechanical joints where possible (i.e., perlite fill nozzles)
- New vacuum header design
 - Allow better top/bottom communication (i.e pressure can equalize in the annulus)
 - Better accessibility to components
- Prior to future detankings
 - Verify no massive air in leakage by monitoring top annulus pressure while performing pressurization cycles
- Better vacuum monitoring
 - Remote top and bottom readings
 - Automated alarms
- Standardize pumping operations
 - Isolate vacuum system post LH loading
 - If pumps are needed then investigate for air in leakage

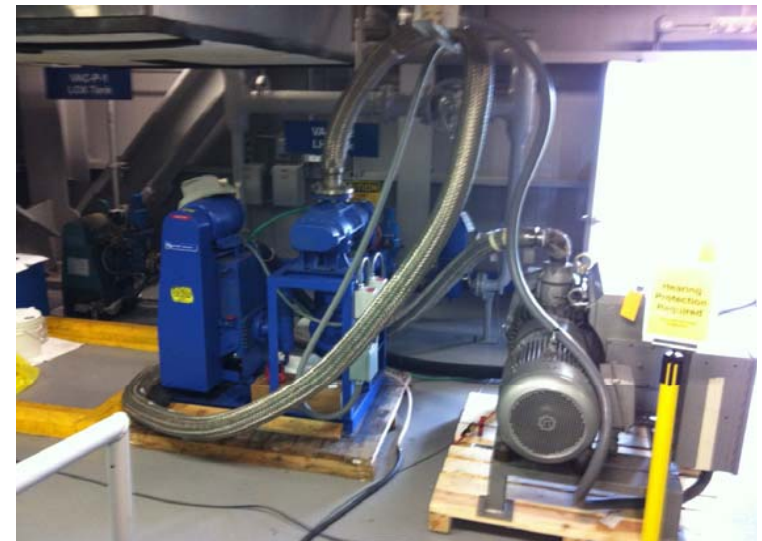
**Rental
Pumps**

- Customer required one more engine hotfire test prior to a three month scheduled outage
- Attempted to remove air (nitrogen and oxygen) in annulus by vaporizing frozen air in annulus:
 - Rented large blower vacuum pump
 - Pressurized inner tank to warm-up tank wall
 - Frozen air sublimated as vessel wall temp rose
 - Monitored/controlled top annulus pressure
- Discovered elevated O₂ in vacuum pump discharge. Rented O₂ rated pump.
 - After ~24 hrs top annulus pressure dropped
- Conducted tank pressurizations tests to show minimal top annulus vacuum rise (< 5 psia)
- Filled run tank to 100%...top annulus dropped from 1.4 psia (~70,000 microns) to 23 microns
- Set observer cutoff limits on top annulus readings
- Successfully completed two engine hotfires
 - November 2nd
 - November 10th
